Report No. : GJ-70244-2025

# inspection report

Product model: R13-DP

Product name: Hydraulic excavator driver  
protection device

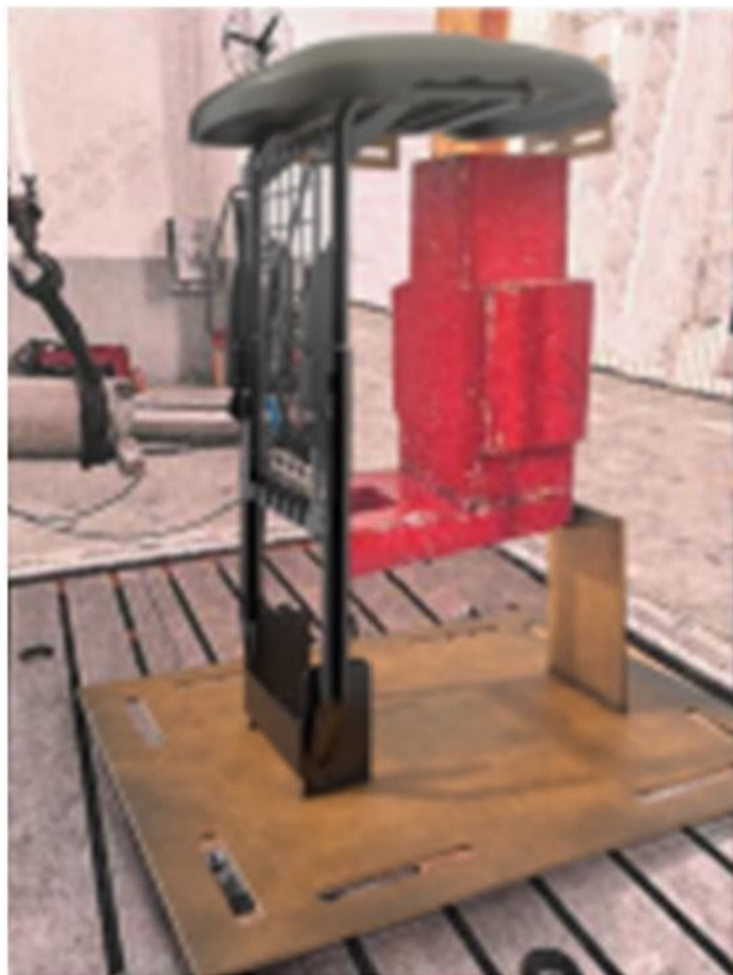
Photo of the sample

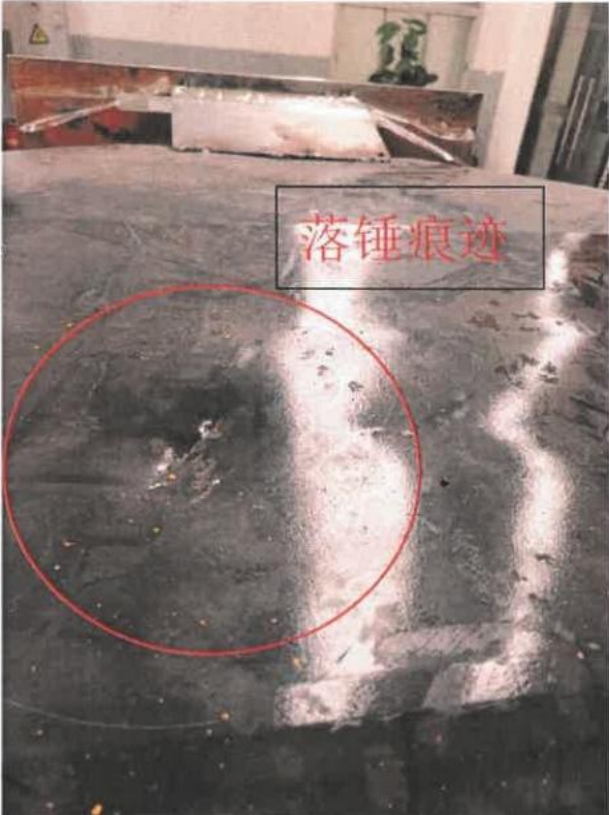
Photo F-1 hammer test

order number	inspecting item	Design or standard requirements	result	conclusion	remarks
1	Energy absorption capacity of top protection device	The top protection device is in place DLV shall not be invaded under initial or subsequent impact under the 1365J energy reference	The hammer impact energy is 1365J after impact, The top protection device is not penetrated and the top protection is maintained The maximum vertical residual deformation of the device is 27mm, top protection device not in DLV	qualified
